Johnson industries / elevanja ltd

RCC SYSTEM OPERATION - TROUBLE SHOOTING

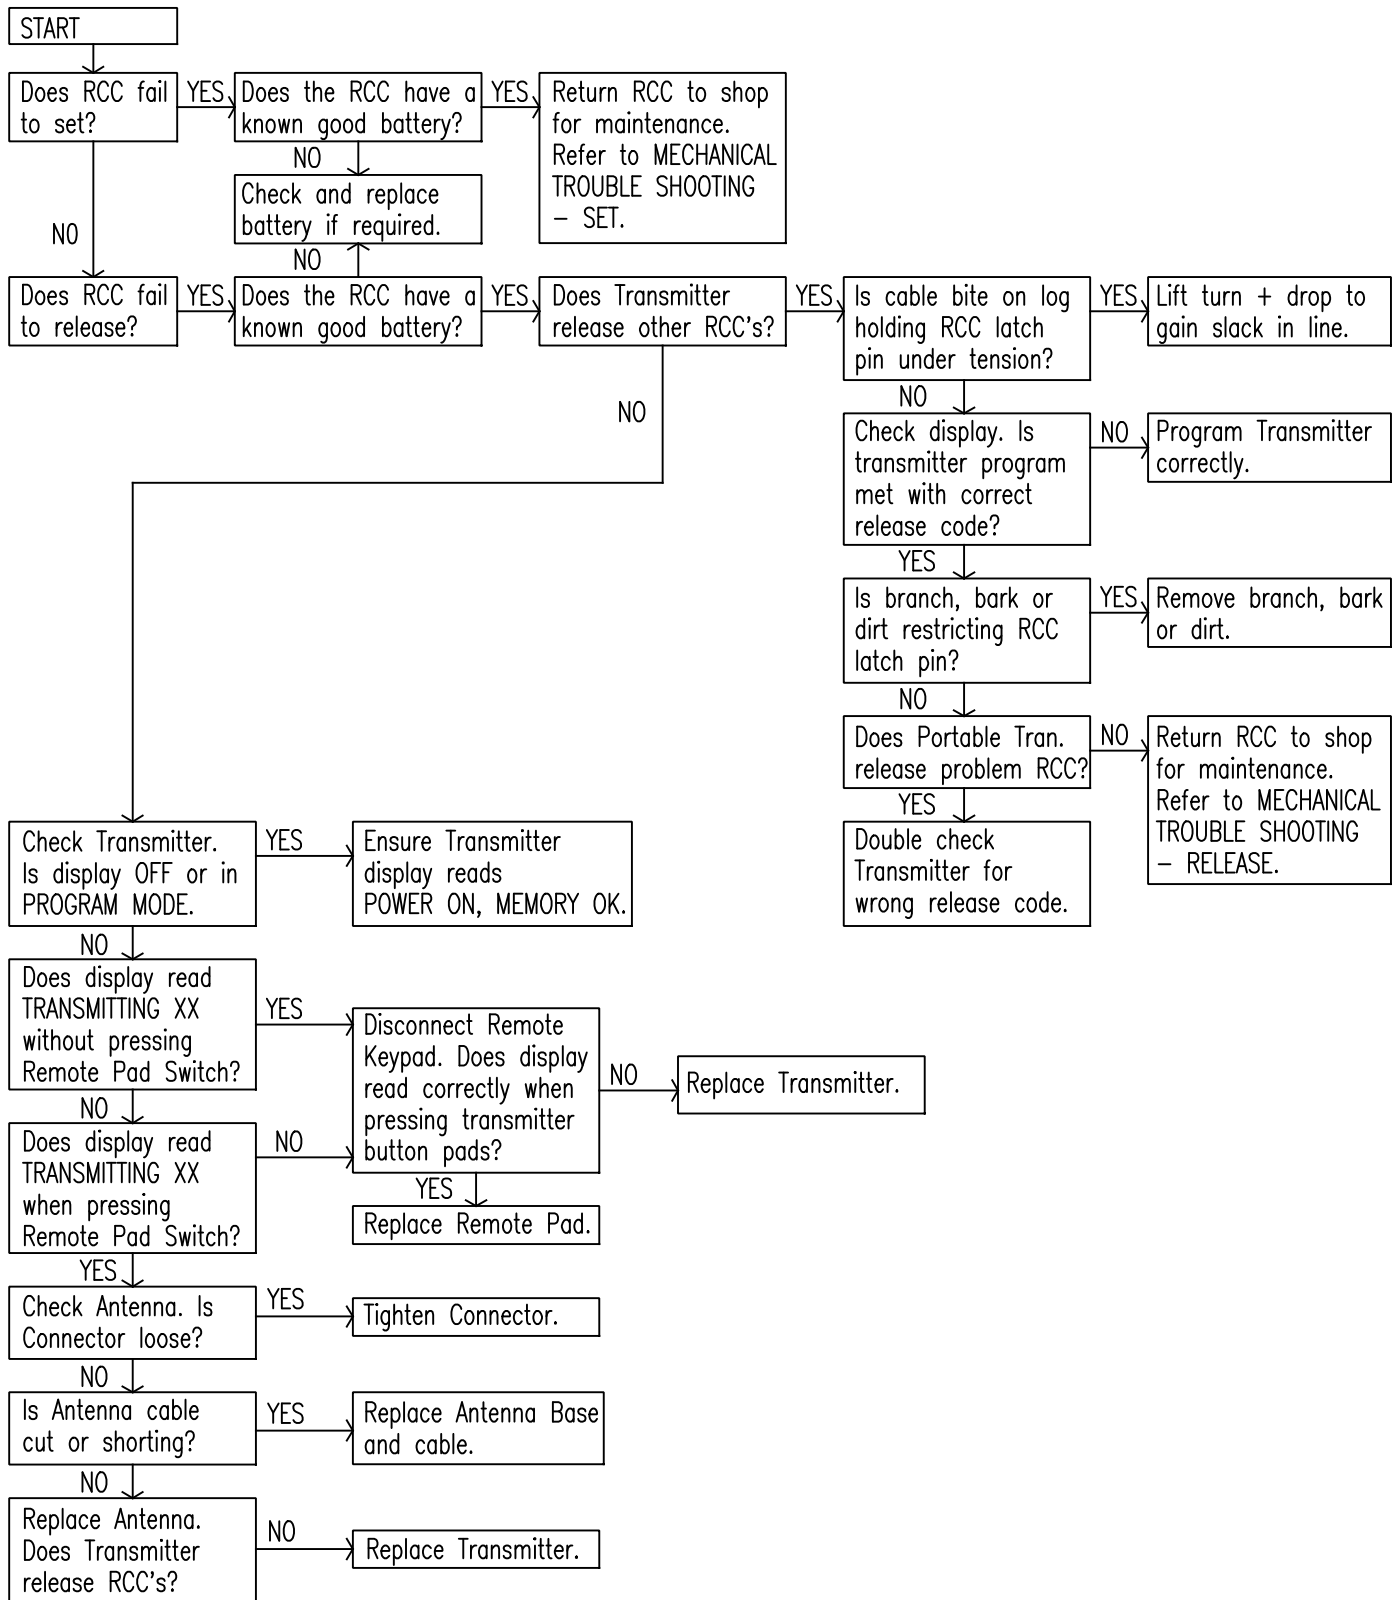
**USE THIS TROUBLE SHOOTING FLOW CHART TO IDENTIFY
PROBLEM COMPONENT WHEN RCC FAILS TO FUNCTION PROPERLY.**
